UNDERWATER BRIDGE INSPECTION REPORT

STRUCTURE NO. 57503
CSAH NO. 7
OVER THE
RED LAKE RIVER
DISTRICT 2 - PENNINGTON COUNTY

PREPARED FOR THE
MINNESOTA DEPARTMENT OF TRANSPORTATION
BY
COLLINS ENGINEERS, INC.
JOB NO. 5221 (CEI 164)

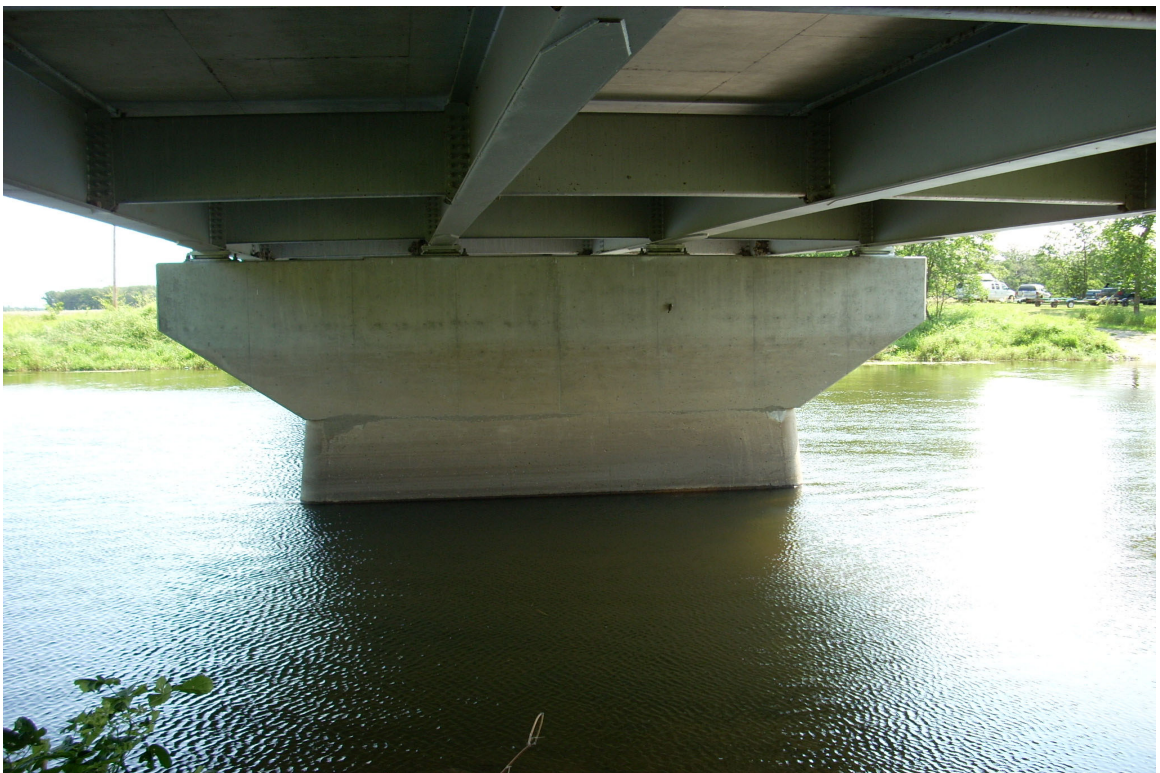
- (A) An 8-inch length of exposed reinforcing steel was observed at the waterline at the upstream end of Pier 1.
- (B) A minor scour depression, which was 3 feet in diameter and 1 foot deep, was observed at the upstream end of Pier 2.
- (C) A moderate accumulation of timber debris, which included drift up to 1 foot in diameter, was observed around the upstream nose from the channel bottom to the waterline and extending 10 feet off the faces and noses of Pier 1.

Photograph 2. View of Pier 1, Looking East.

- (A) Remove the timber debris from around Pier 1 to alleviate further accumulations, scour influence, and excessive lateral loads on the pier.
- (B) Reinspect the submerged substructure units at the normal maximum recommended (NBIS) interval of five (5) years.

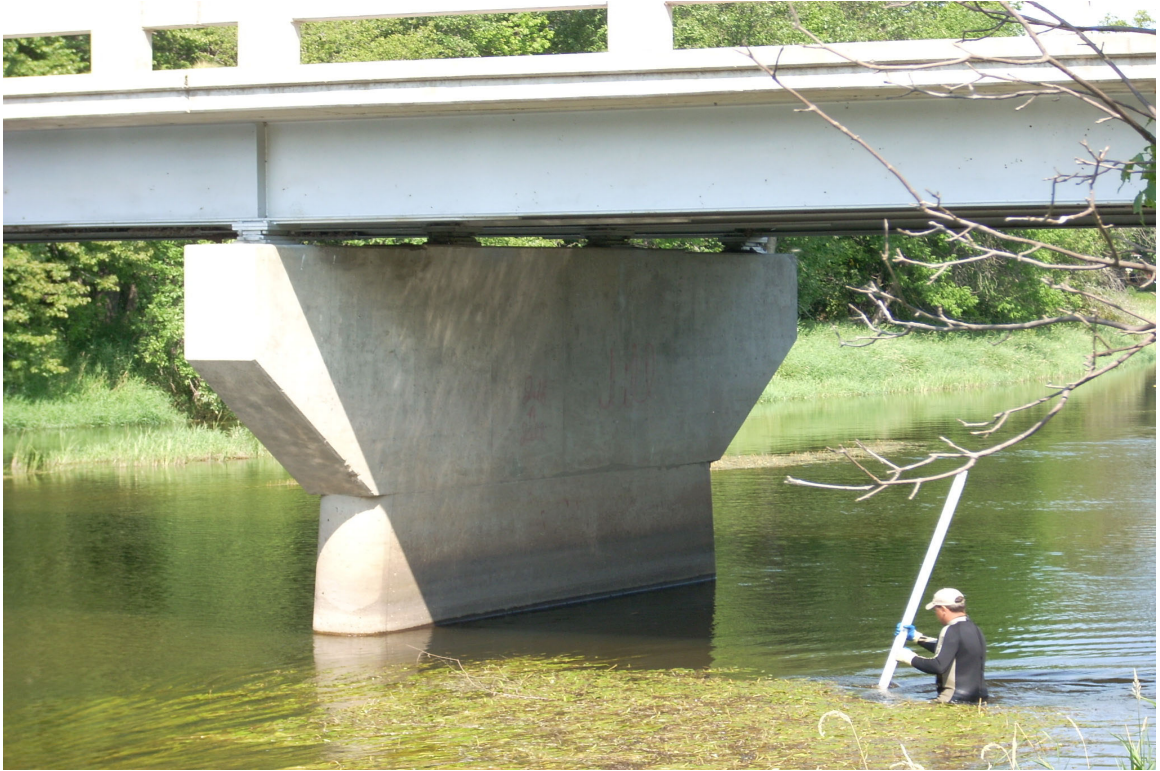
Photograph 3. View of Pier 2, Looking Northwest.

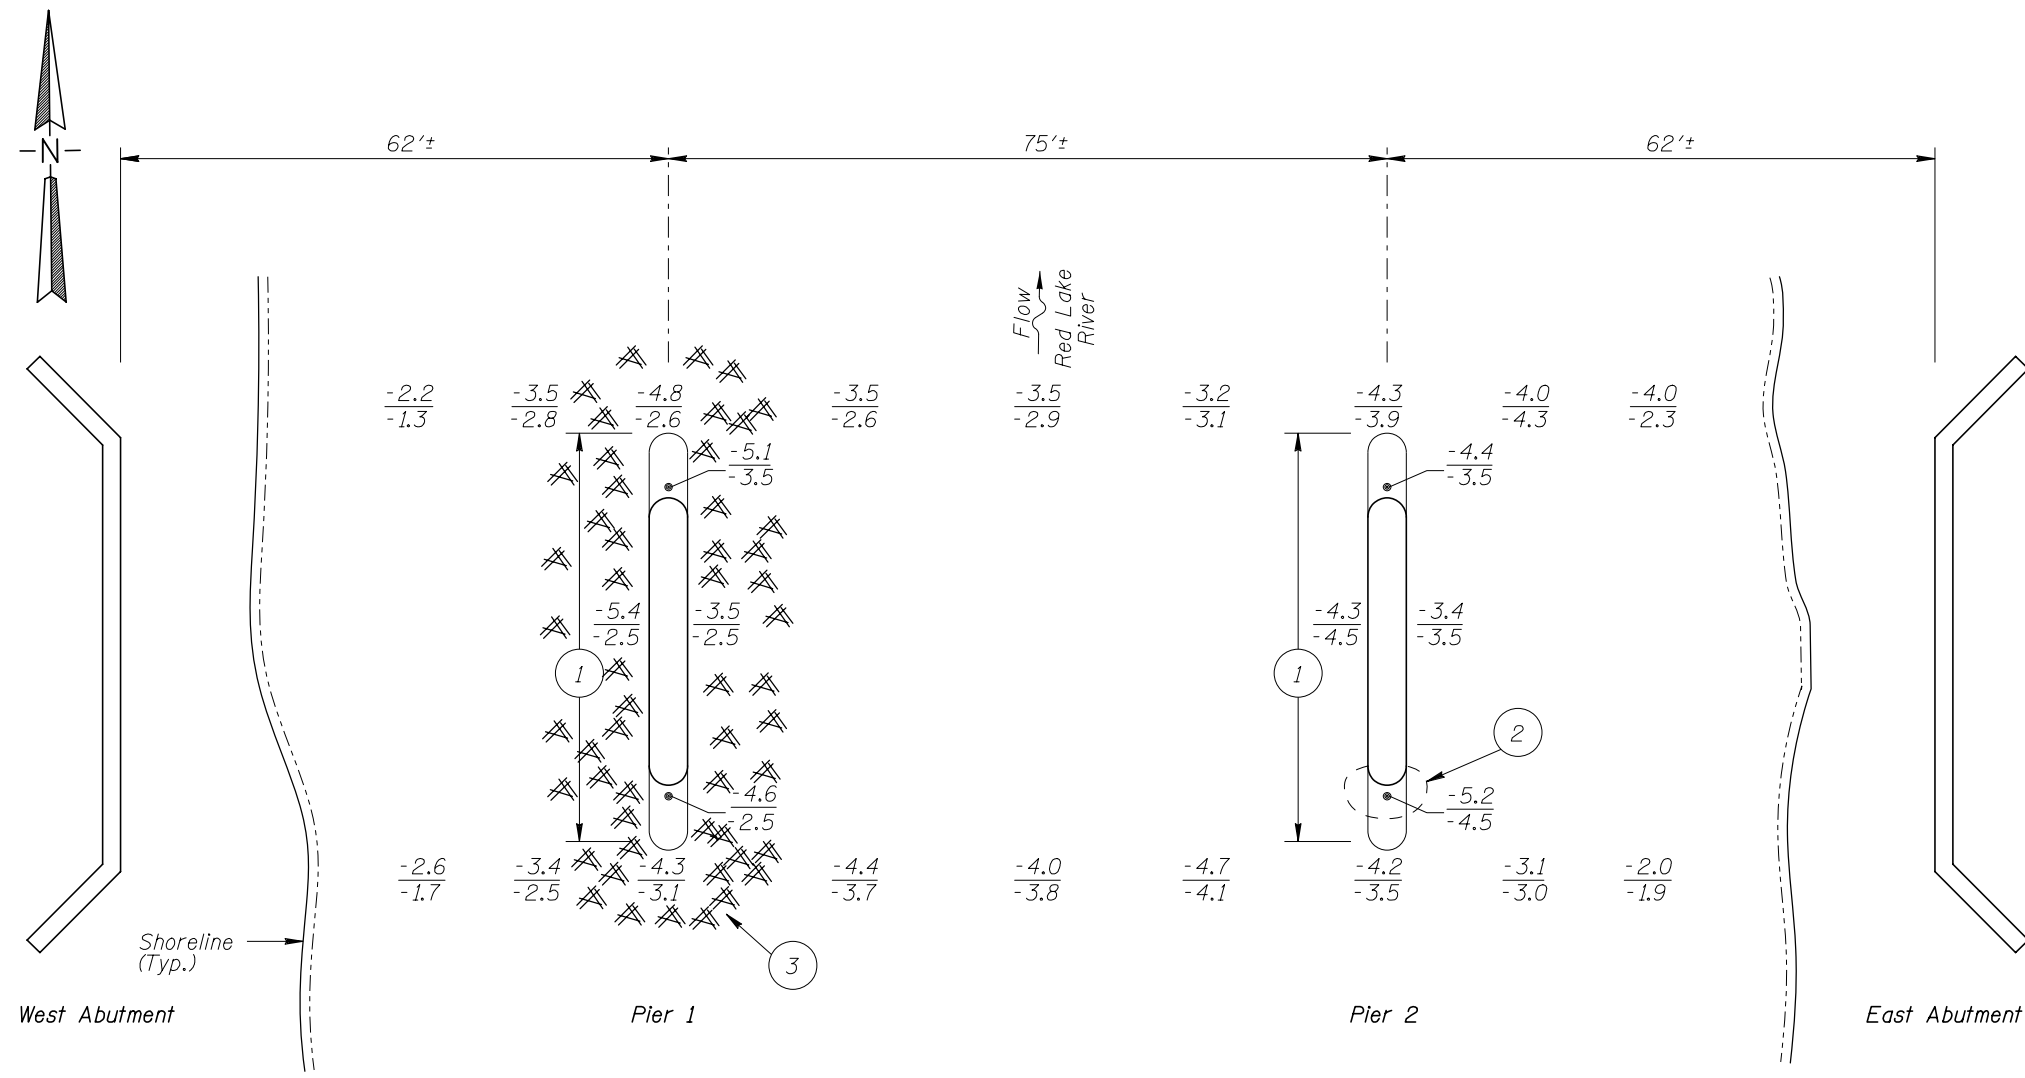
INSPECTION AND SOUNDING PLAN

- 1 Overall, the concrete piers were smooth and sound with an 8-inch length of exposed reinforcing steel located at the waterline at the upstream end of Pier 1. In addition, minor scaling was observed at the upstream nose of Piers 1 and 2 from channel bottom to 4 feet above the waterline.
- 2 A minor scour depression, 1 foot deep with a radius of 3 feet, was observed at the upstream end of Pier 2.
- 3 A moderate accumulation of timber debris, which included drift up to 1 foot in diameter, was observed around the entire perimeter of Pier 1 from the channel bottom to the waterline and up to 10 feet off the pier faces and noses.
- 4 The channel bottom around the entire perimeters of Piers 1 and 2 consisted of sand and gravel and random rip rap up to 1 foot in diameter with up to 6 inches of probe rod penetration.
